# **Avnet PicoZed 7010/7020 Revision C Errata**

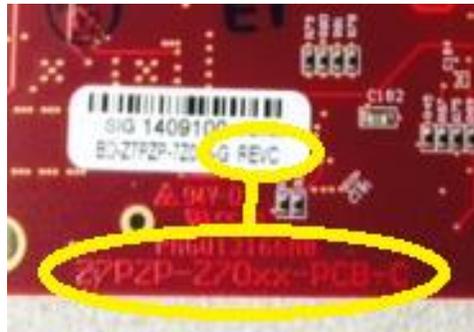
Figure 1 – Identifying PicoZed 7015/7030 for this Errata

The modules affected by these errata can be identified by the Revision of the PicoZed System-On-Module. The revision of the PicoZed System-On-Module can be found on the bottom side of the PCB board. The affected PCB boards are the PicoZed 7015 / 7030 Revision C, identified as PCB part number "**Z7PZP-Z70xx-PCB-C**" and the BOM Revision Part Number, "**REVCxx**", where the 'xx' is the revision of the BOM on the module.

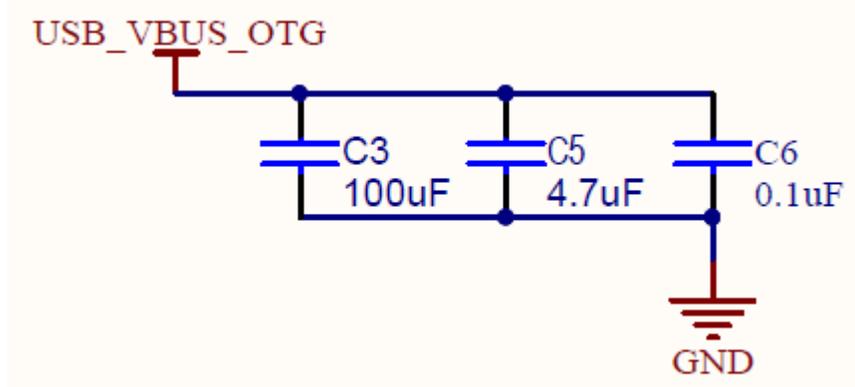
Figure 3 – Extra Caps on PicoZed 7010/7020 Rev C

The Microchip USB3320 outlines very specific capacitance guidelines for setting the PHY mode to Host, Device, or OTG. To keep the PicoZed as flexible as possible, the Mode setting capacitors must be placed on the Carrier based on the operating USB mode the user requires. On Rev C, extra bypass capacitors were placed on the JX3 connector that may interfere with this mode setting.

Depopulate C3, C5, and C6 on the SOM.

This fix is implemented on PicoZed 7010/7020 Revision D.
